BUTRINT 6

EXCAVATIONS ON THE VRINA PLAIN

Volume 1

THE LOST ROMAN AND BYZANTINE SUBURB

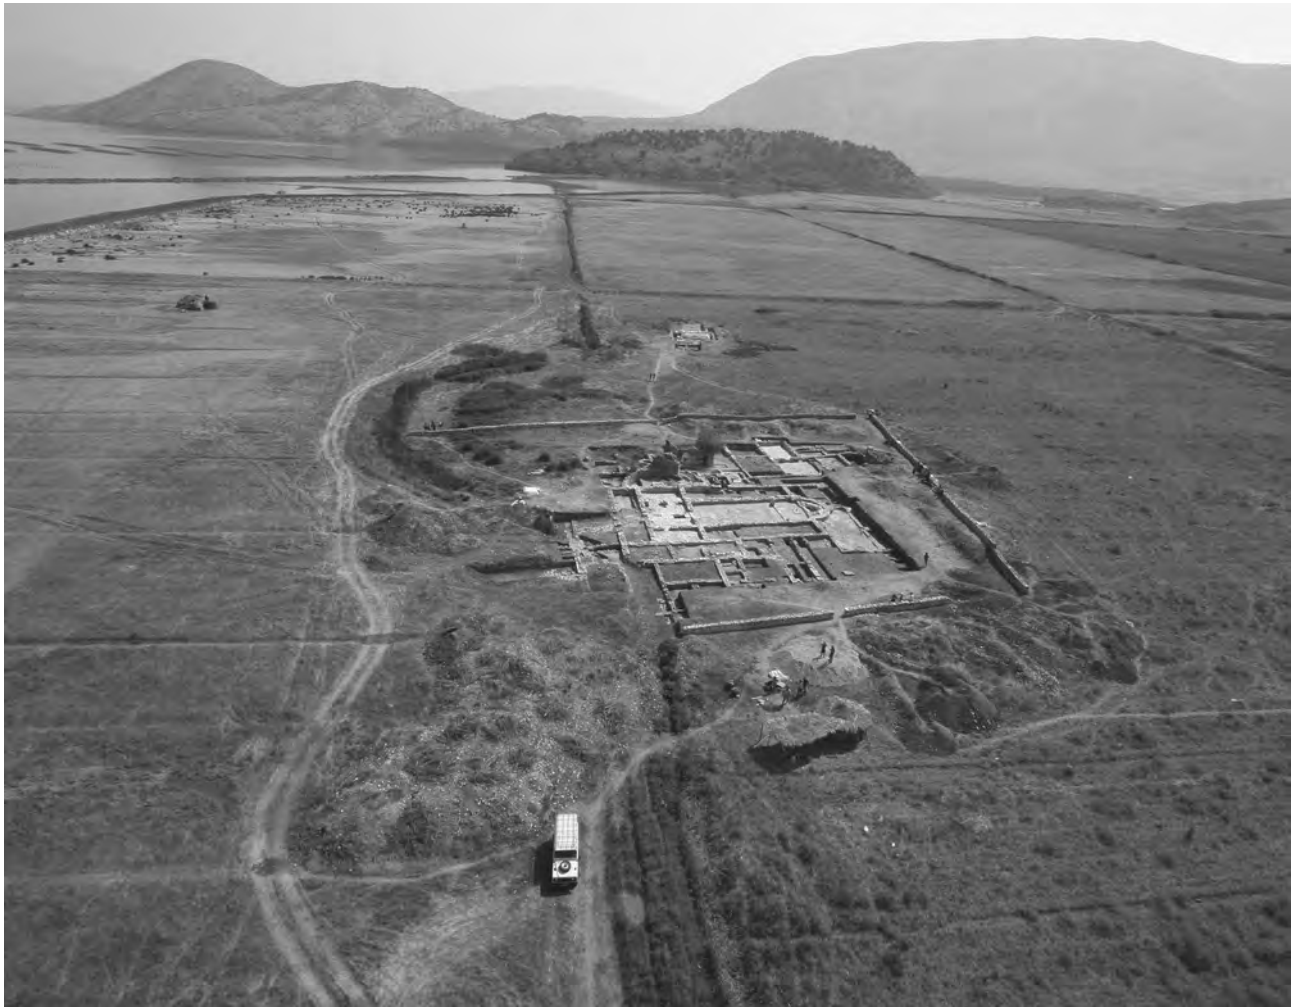
Figure 1.10. View of the Vrina Plain excavations looking along the line of the drainage ditch

The excavations were initially centred on one of the large drainage ditches which criss-cross the plain (Fig. 1.10). Unlike the majority of the ditches, which ran straight across the plain, the ditch chosen to be investigated had been dug with a large kink in it. This deliberate bend was necessary

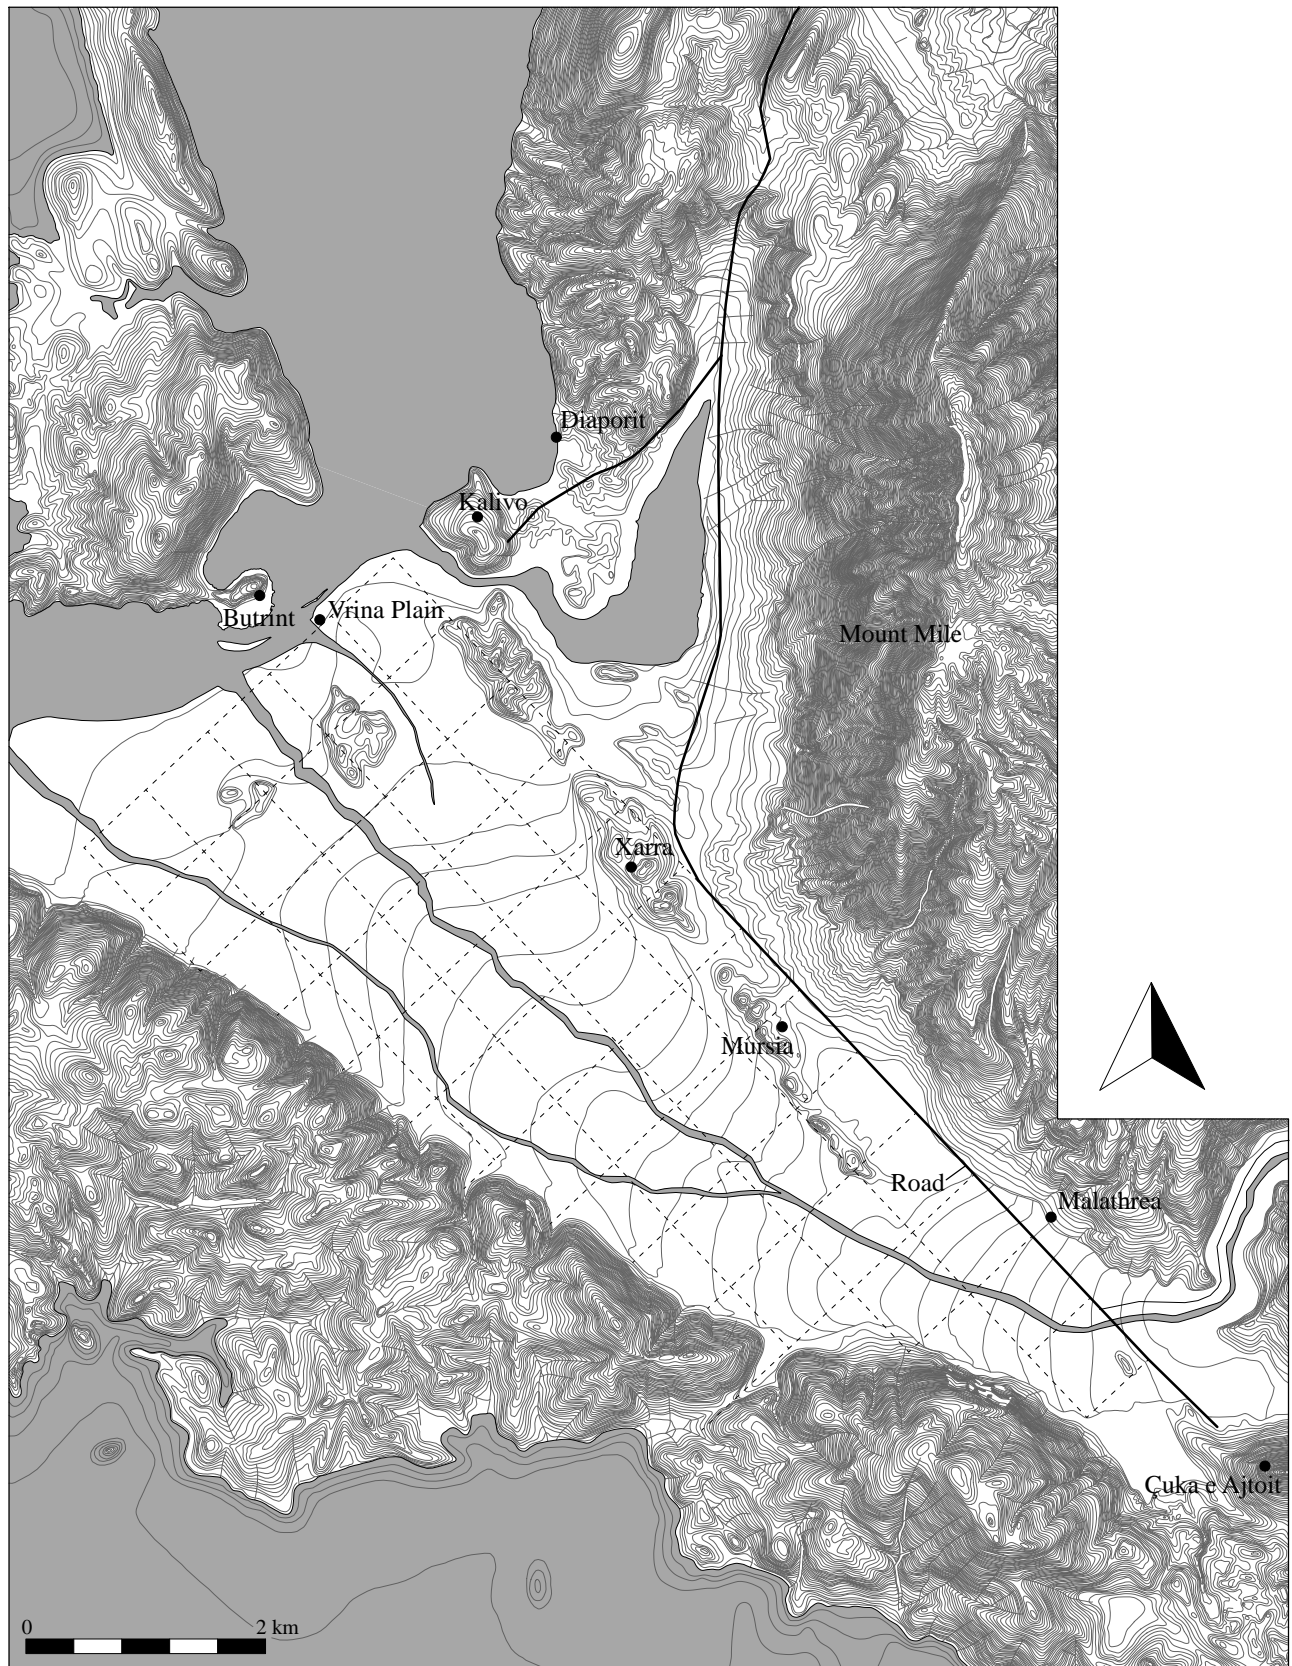
Figure 2.1. The hypothesised route of the pre-existing road, linking a chain of known sites along the edge of the valley and 20×20 actus scheme of land division identified in 2006

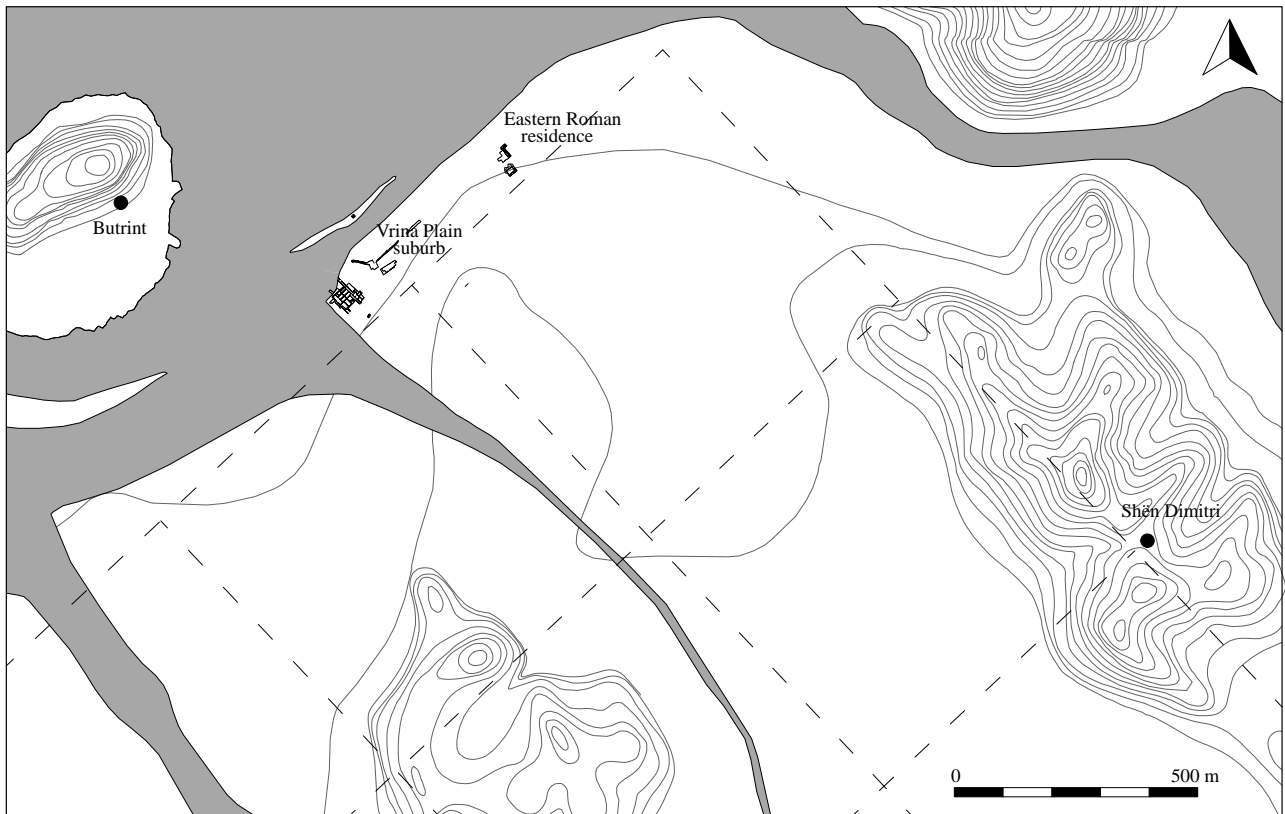
Figure 2.2. The spatial arrangement of known building remains on the Vrina Plain, in relation to the hypothesised centuriation grid

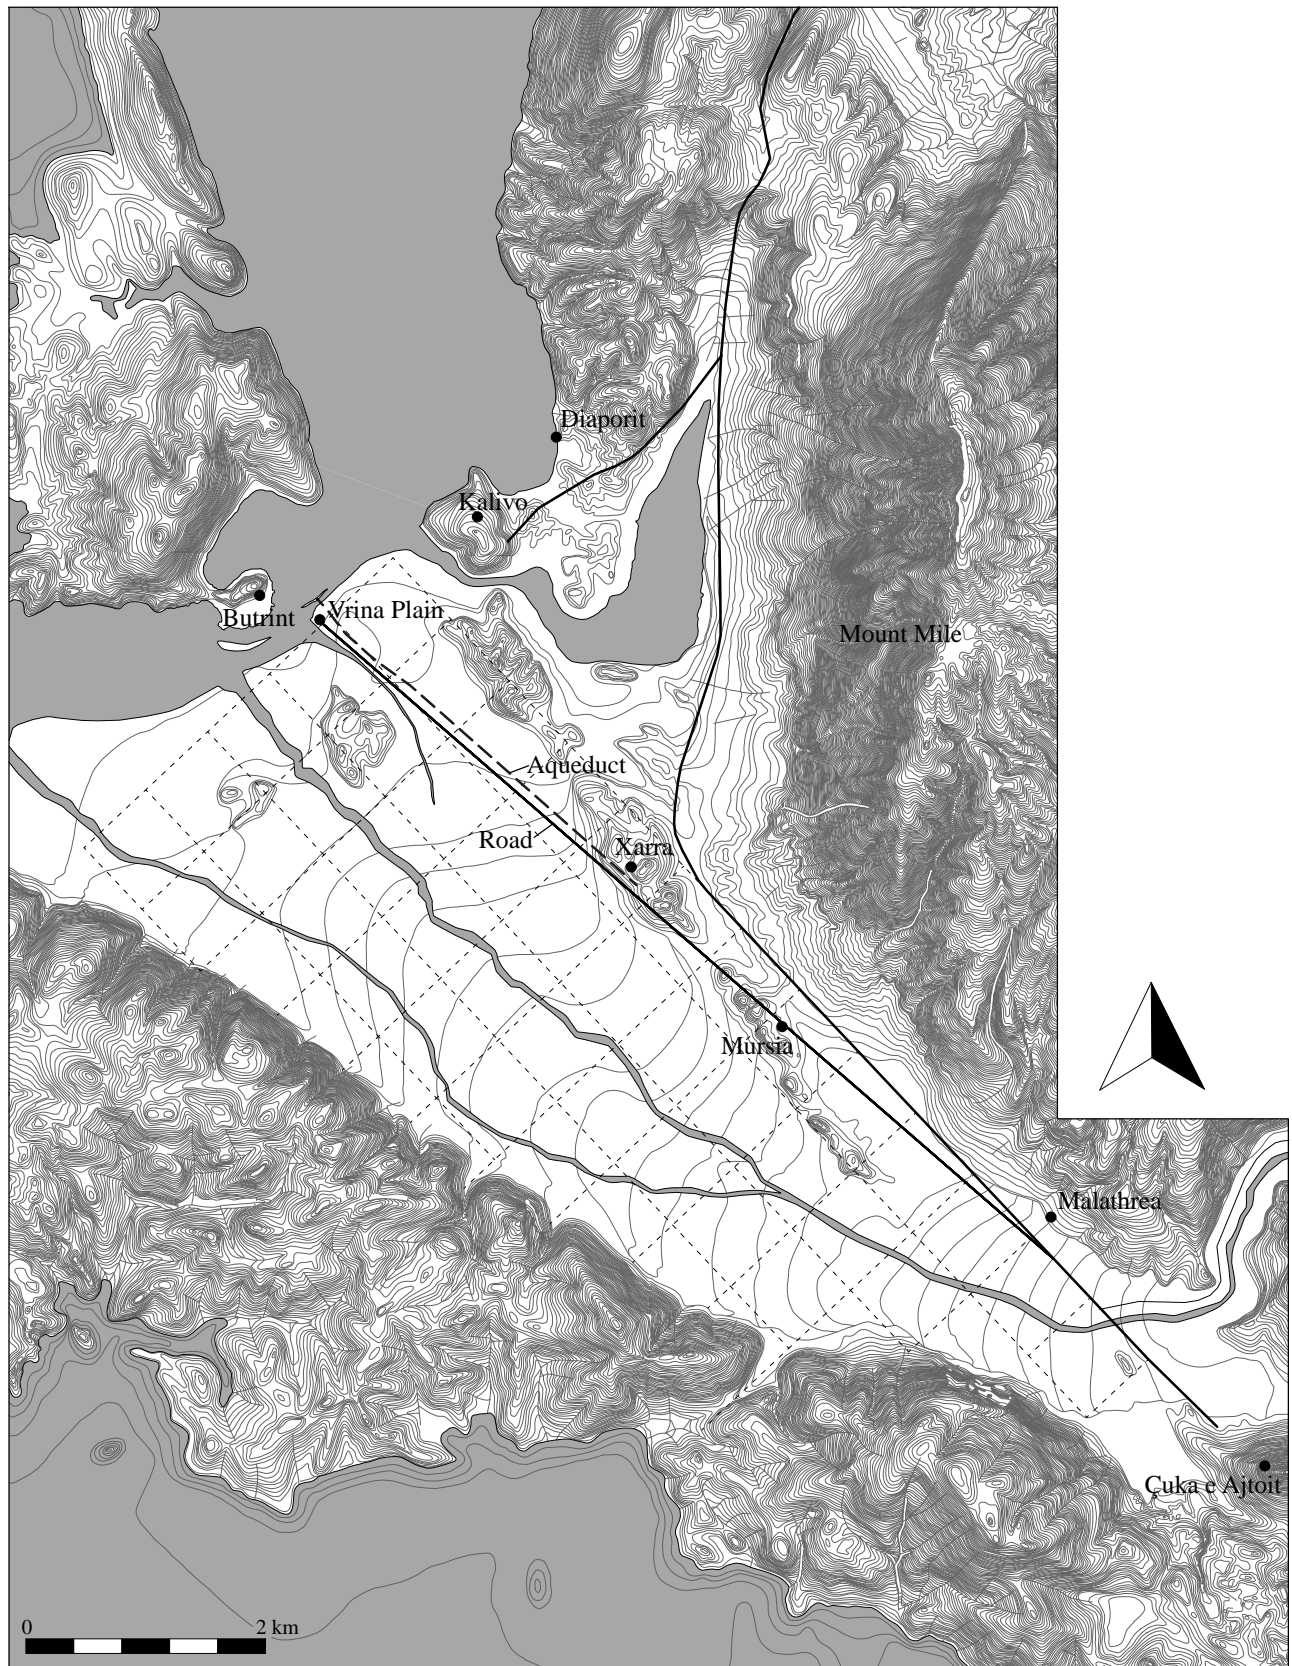
Figure 2.4. Line of hypothetical southern approach road, running alongside the aqueduct

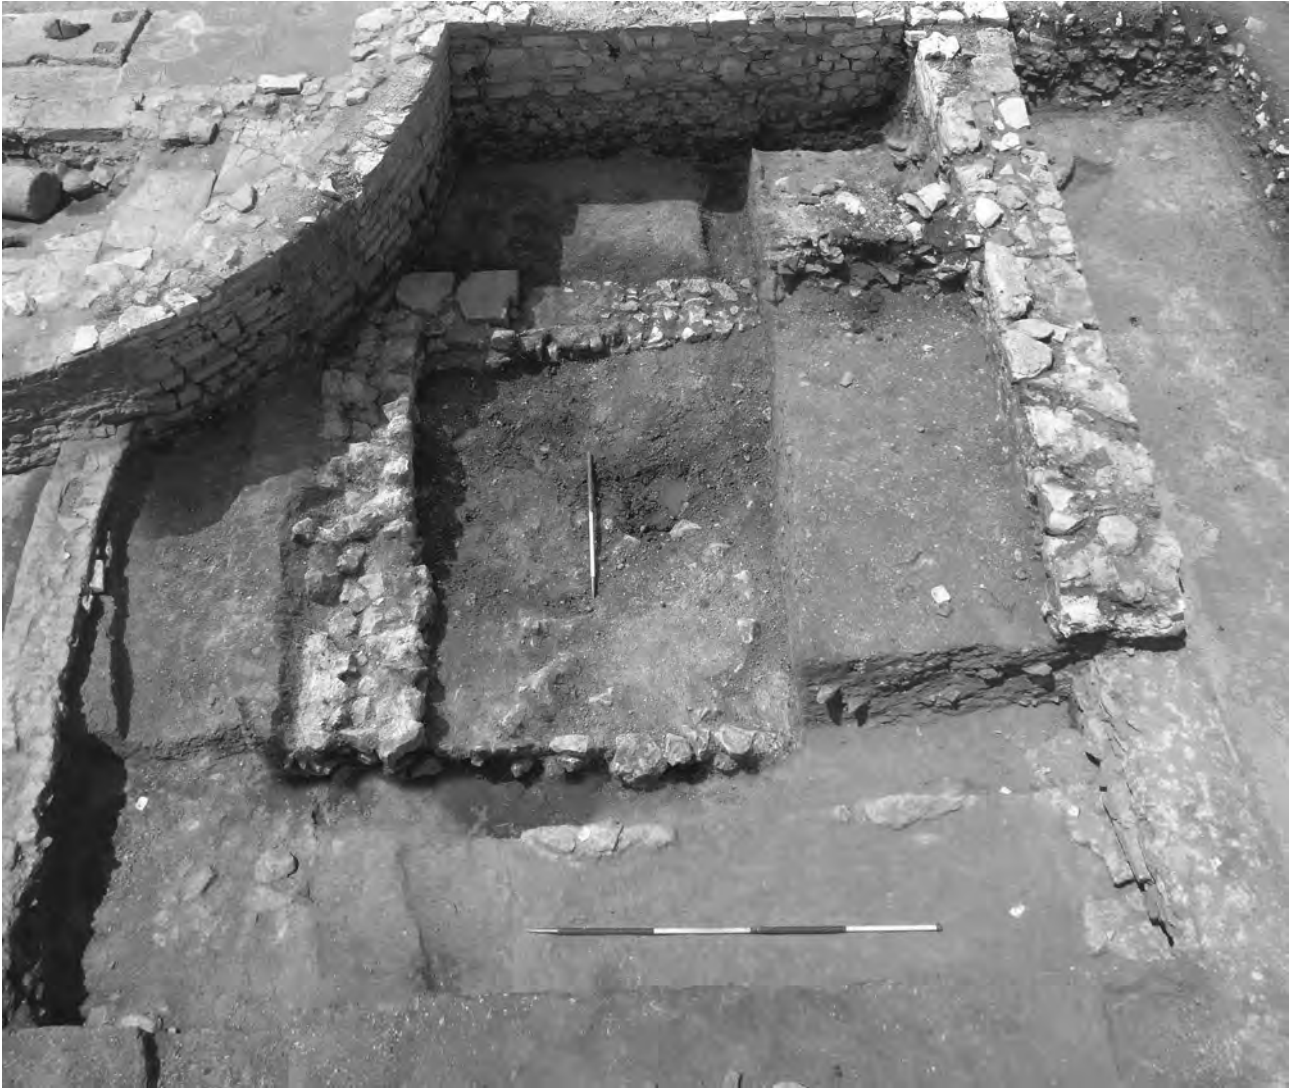
Figure 3.9. Building 1, looking north (1 m and 2 m scales). The earlier features pre-dating Building 1 shown in Figure 3.7 can be seen beyond the northern wall of Building 1

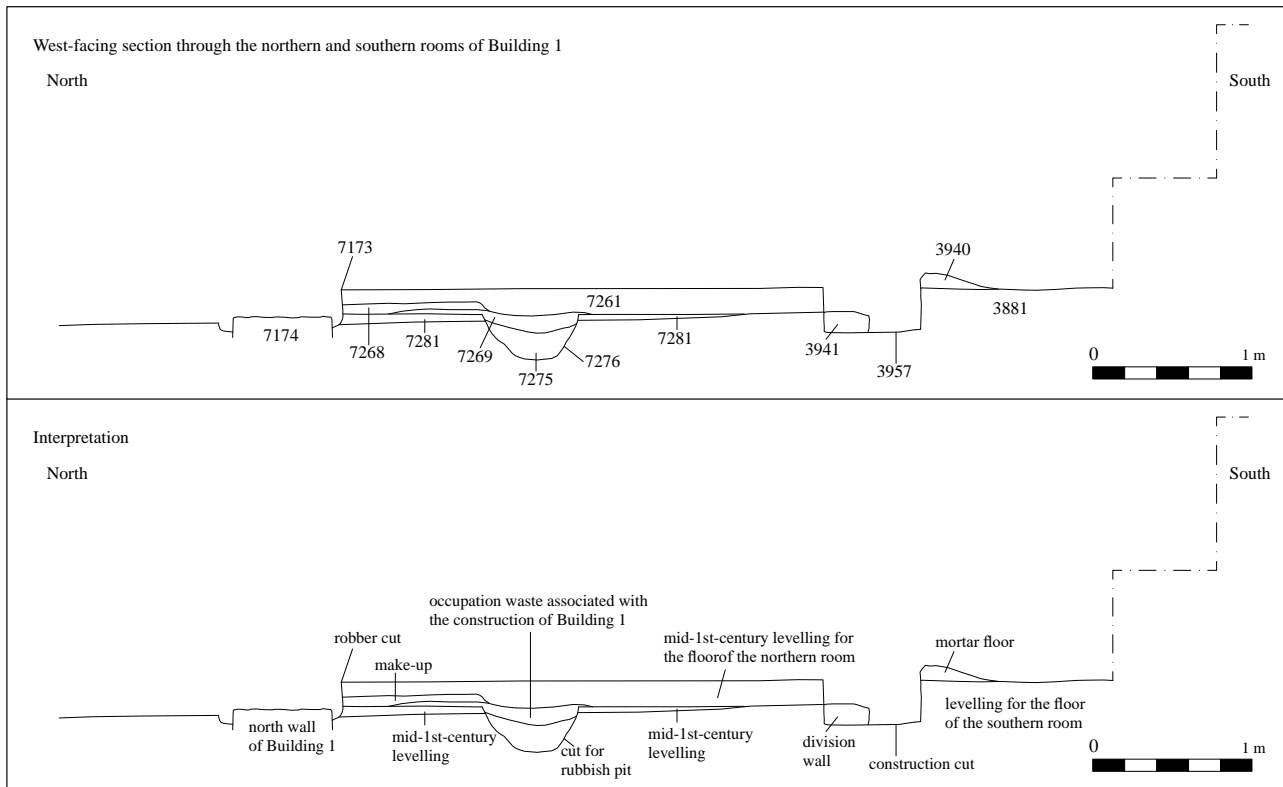
Figure 3.12. West-facing section across Building 1. See Fig. 3.8 for location

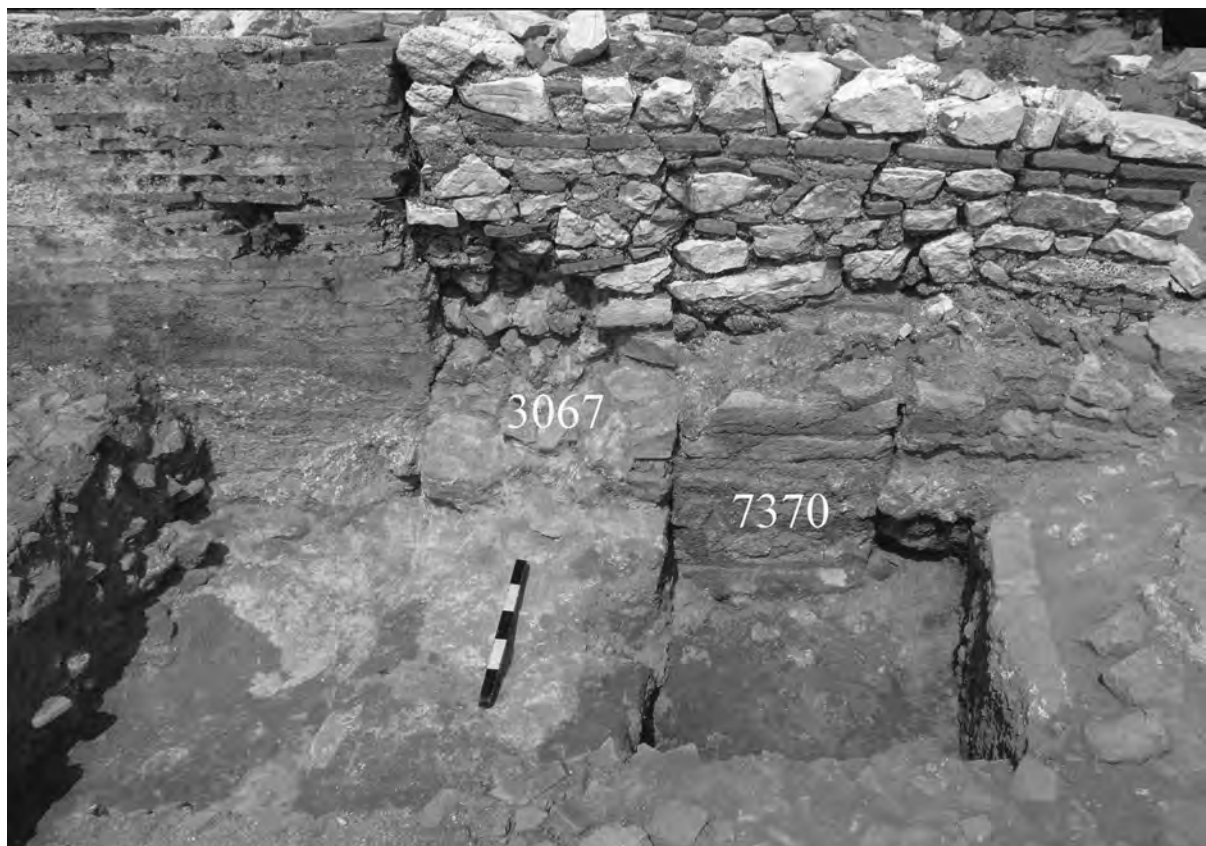
Figure 3.55. Pier 7370 abutting the southern side of wall 3067 (50 cm scale)

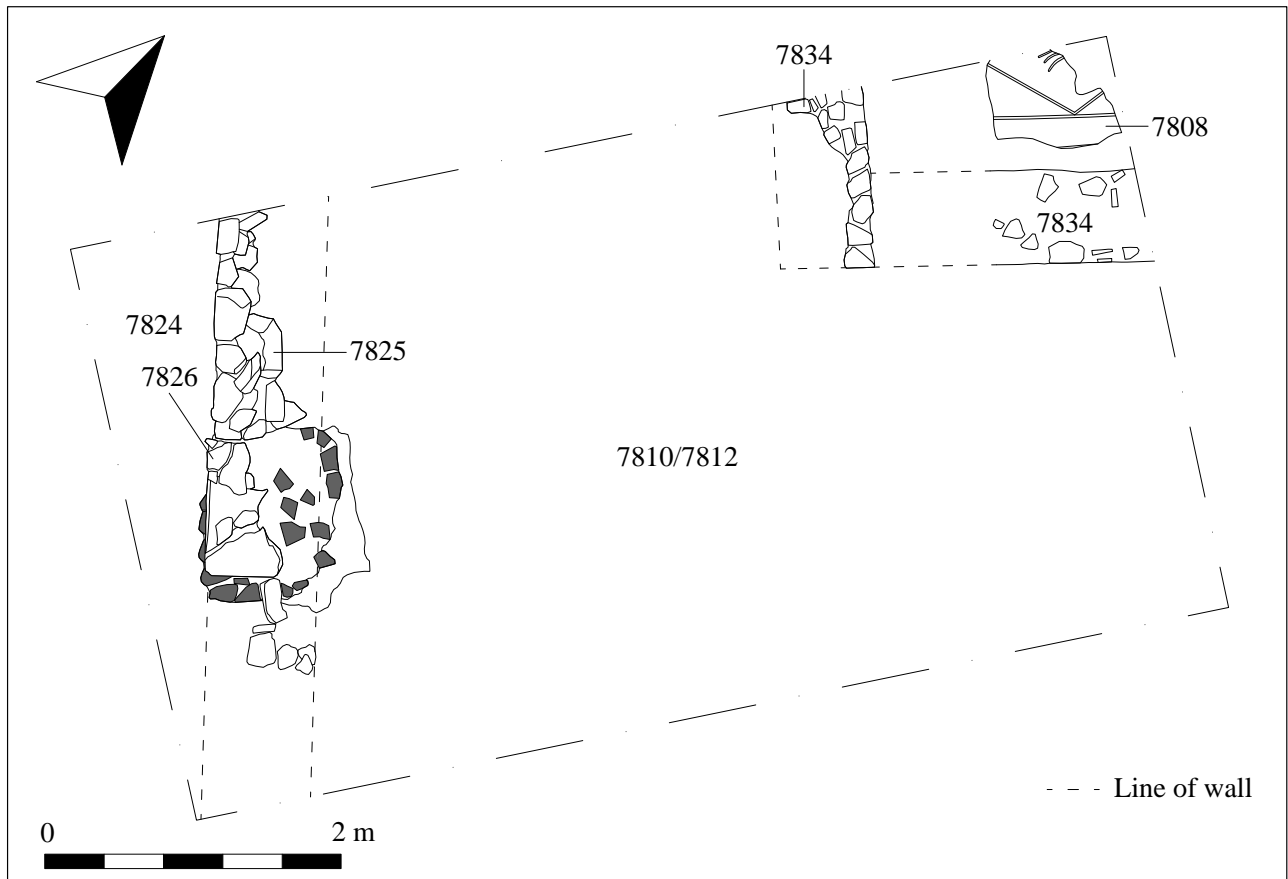
Figure 3.64. Building 6 in Phase 2

To the south, Building 6 also seems to show some signs of alterations at this time (Fig. 3.64). The wall 7829 (see Fig. 3.30) was removed and replaced by a new wall aligned north–south (7825). Built of a mix of roughly cut limestone blocks and tiles bonded with a light-cream sandy mortar, wall 7825 was constructed over the western end of the earlier wall 7829 and abutted the northern face of pier 7826 (Fig. 3.65). A rough line of stones on the southern side of pier 7826 suggests the line of wall 7825 probably continued to the south of pier 7826, although this walling had been subsequently removed in a later phase. To the west of wall 7825 a gritty grey-brown clay silt deposit (7824) containing small patches of white mortar and tile fragments was found partially covering the lower part of the wall. Within the top 50 mm of this deposit a concentration of limestone chips and broken *tesserae* was noticed, suggesting that 7824 may have formed the bedding layer for a surface located to the west of the blocking wall 7825. Ceramics dating to the 2nd (or

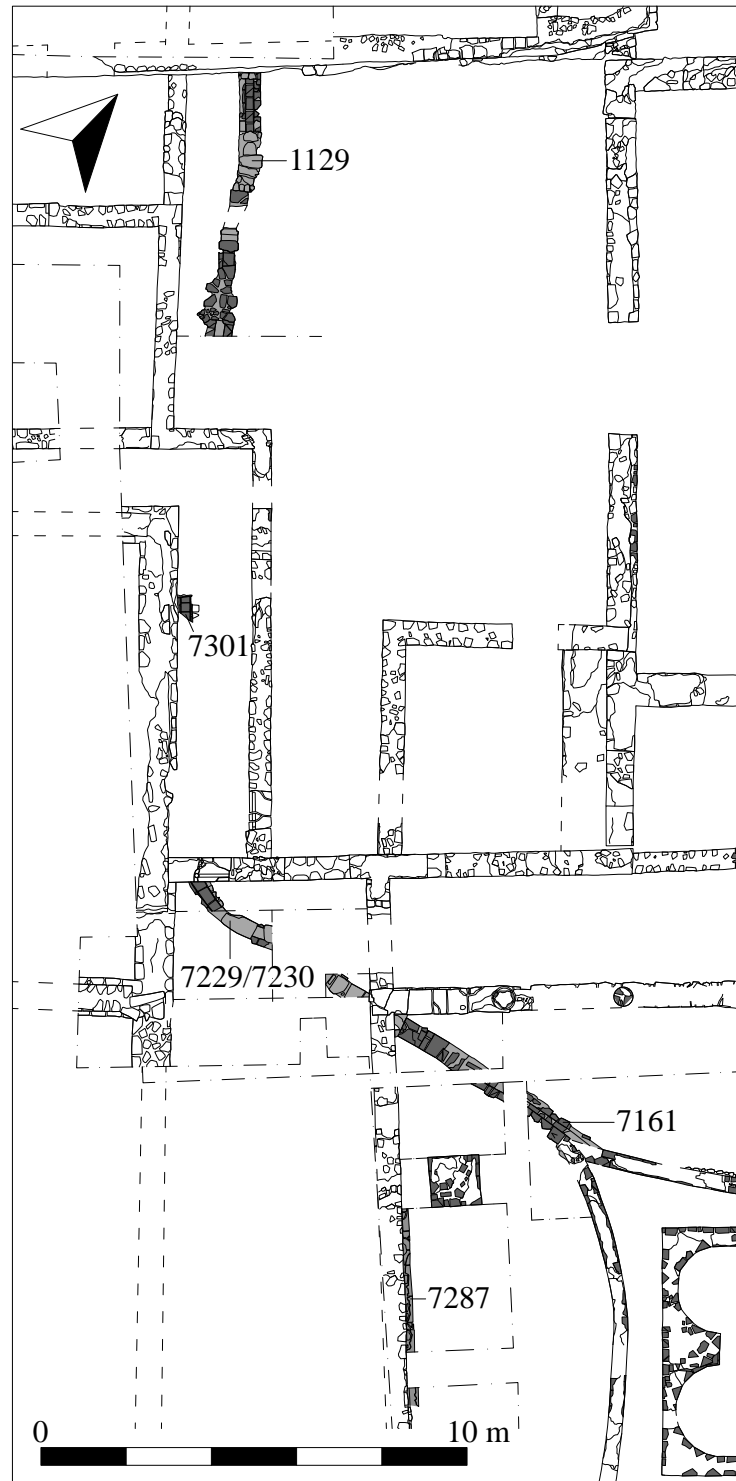
Figure 4.8. Plan showing the alignment of drains 7161/7230/7229/7301/1129 and 7287

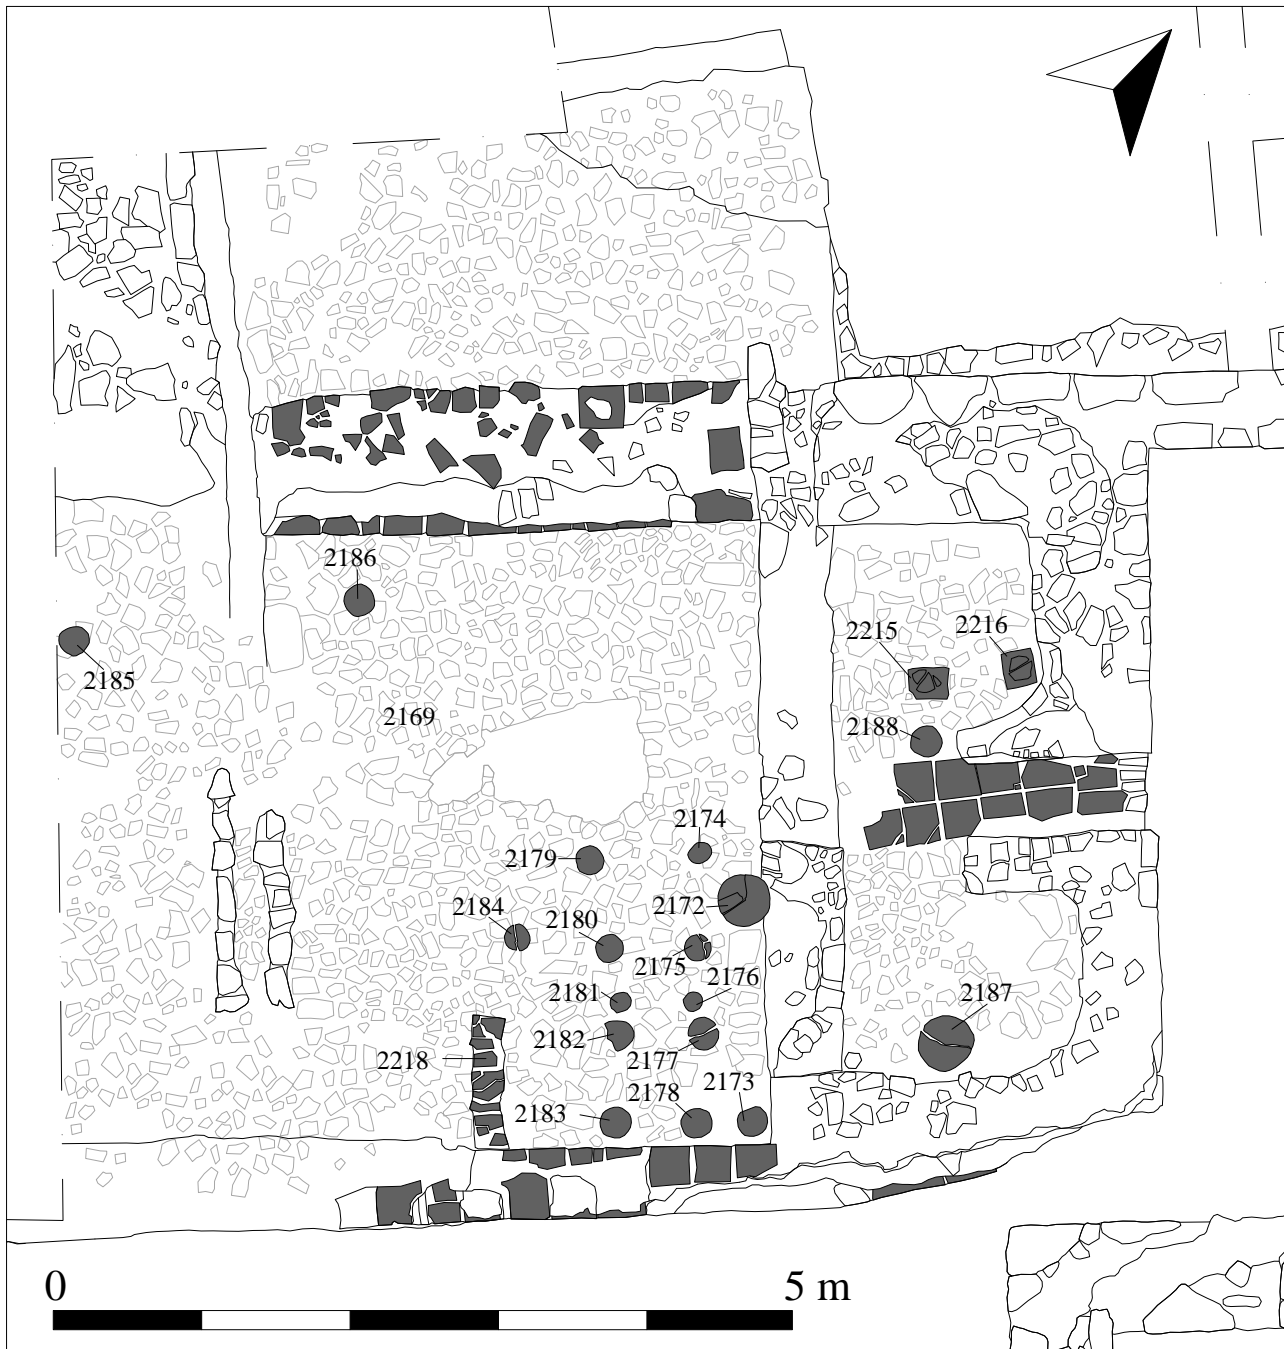
Figure 4.37. Plan of the surviving pilae stacks

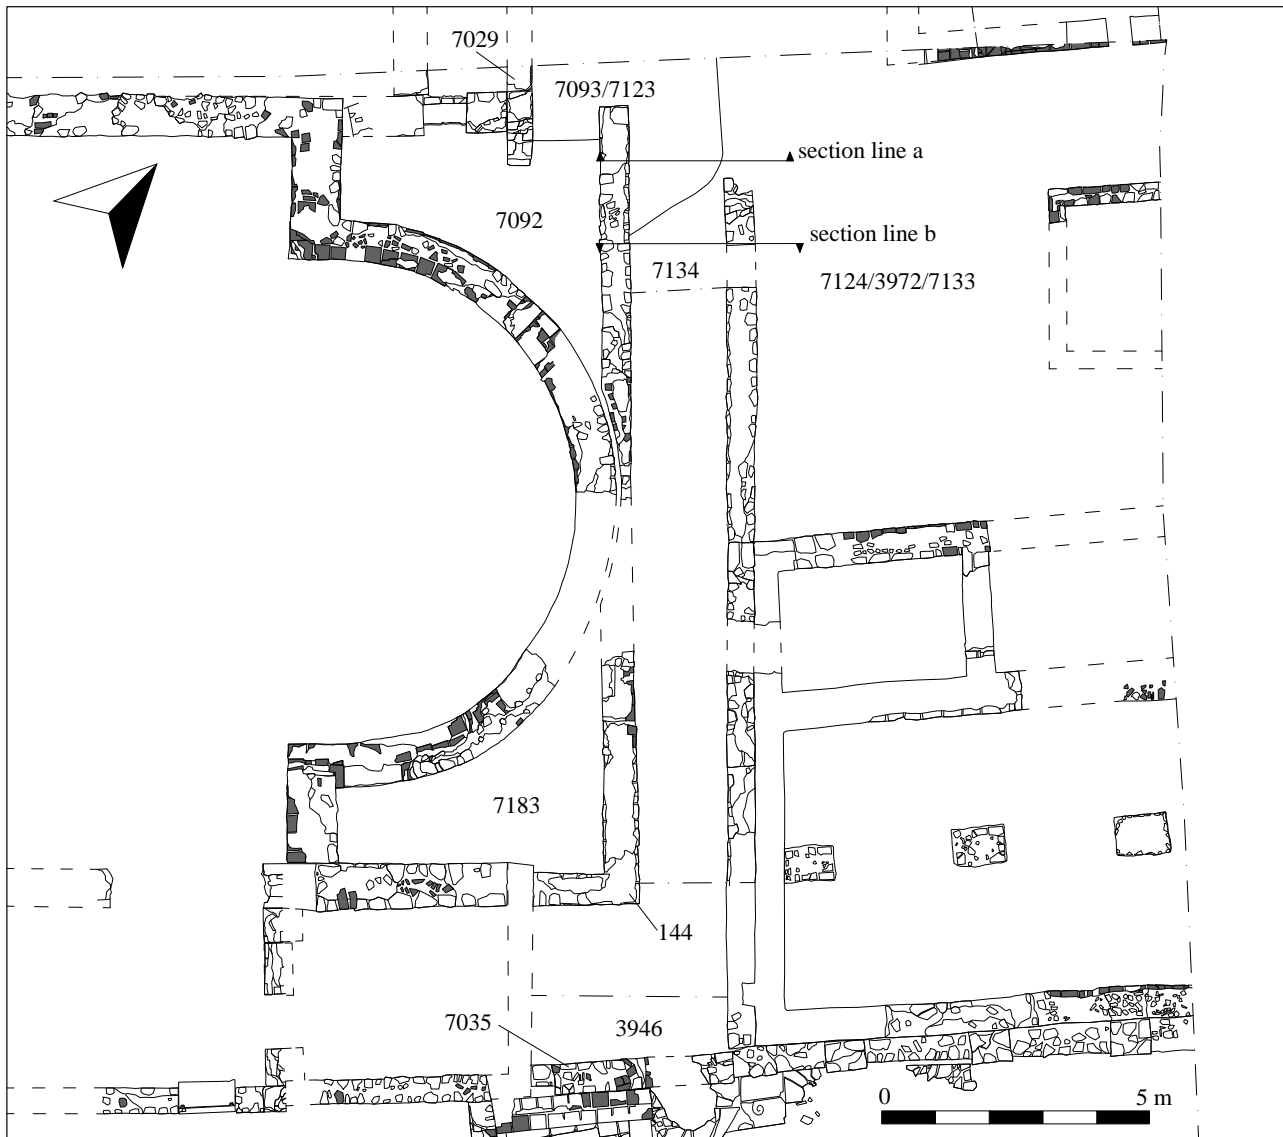
Figure 4.94. Plan of the Phase 3b alterations made to the apse of the apsidal hall and the area to the east of it

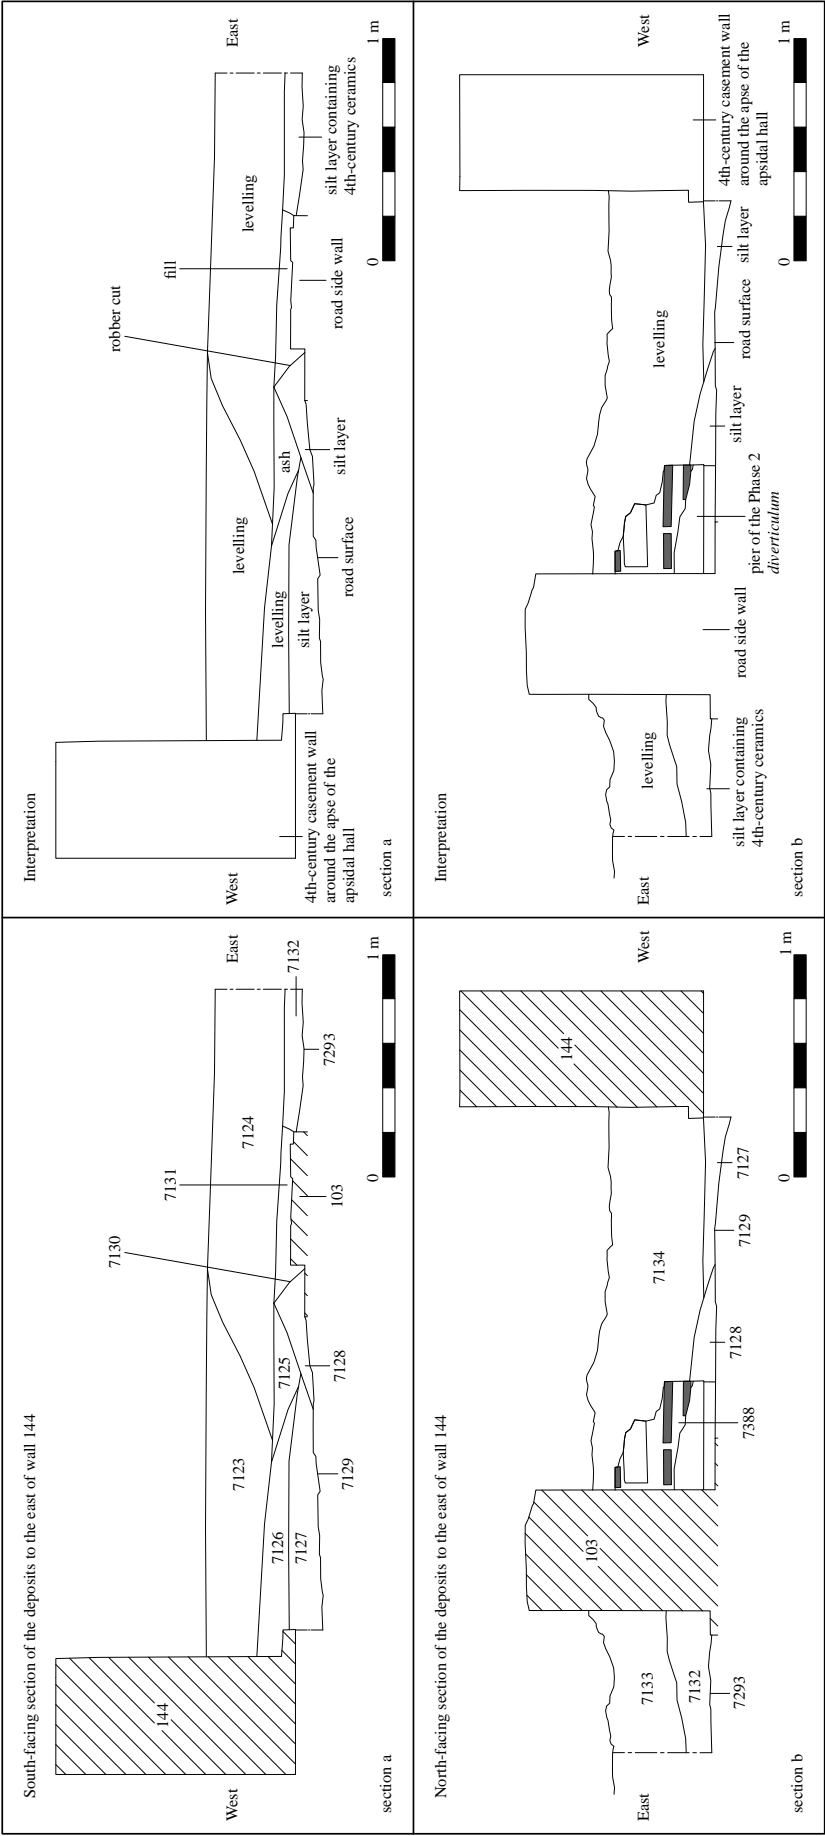
Figure 4.95. North- and south-facing sections across the former channel road showing the deposits infilling it. See Fig. 4.94 for locations

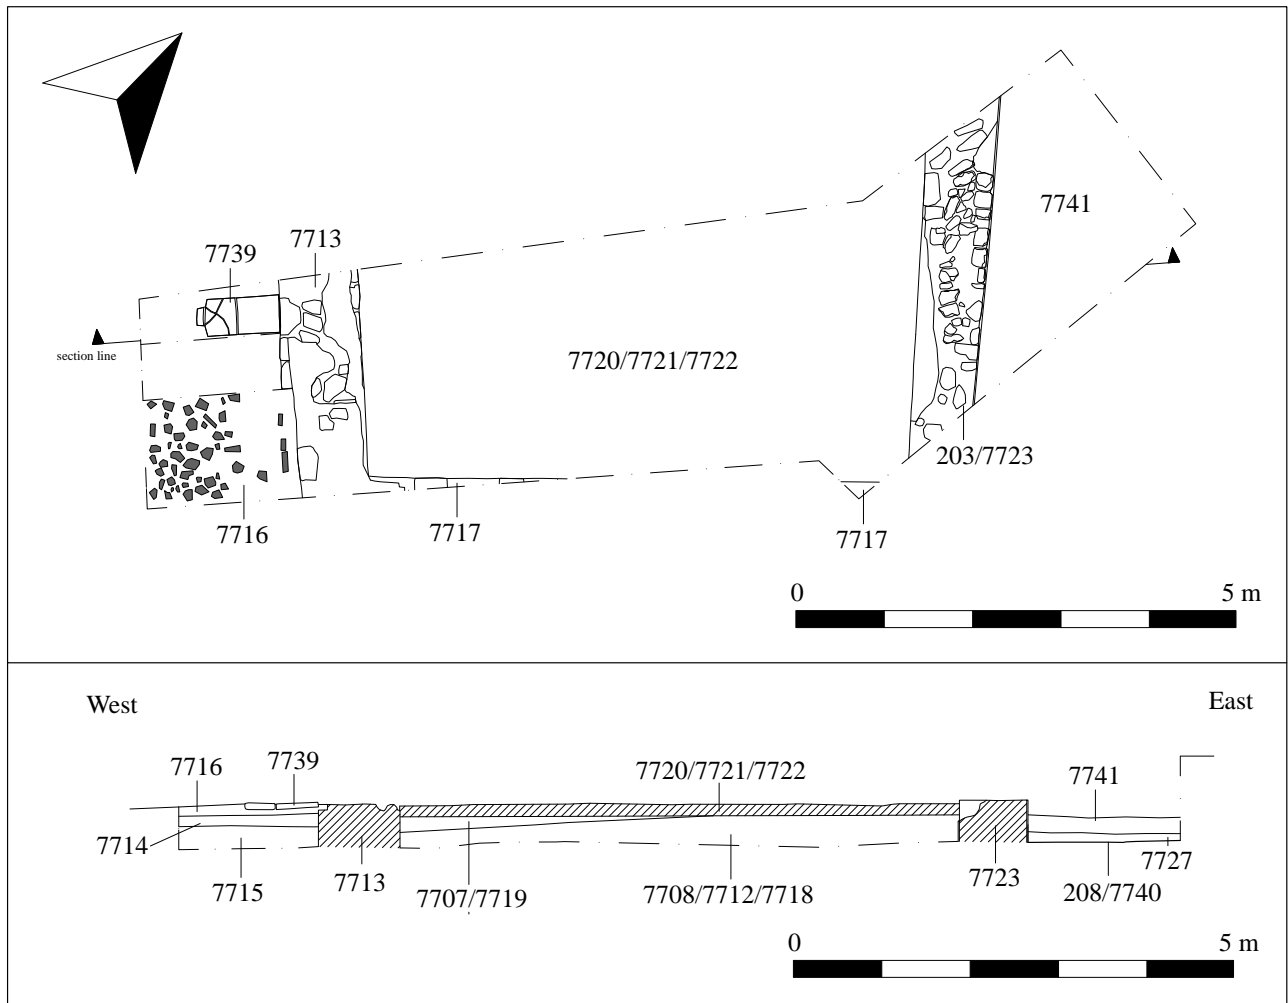
Figure 5.29. Plan and section of the building west of the southern courtyard in Phase 5

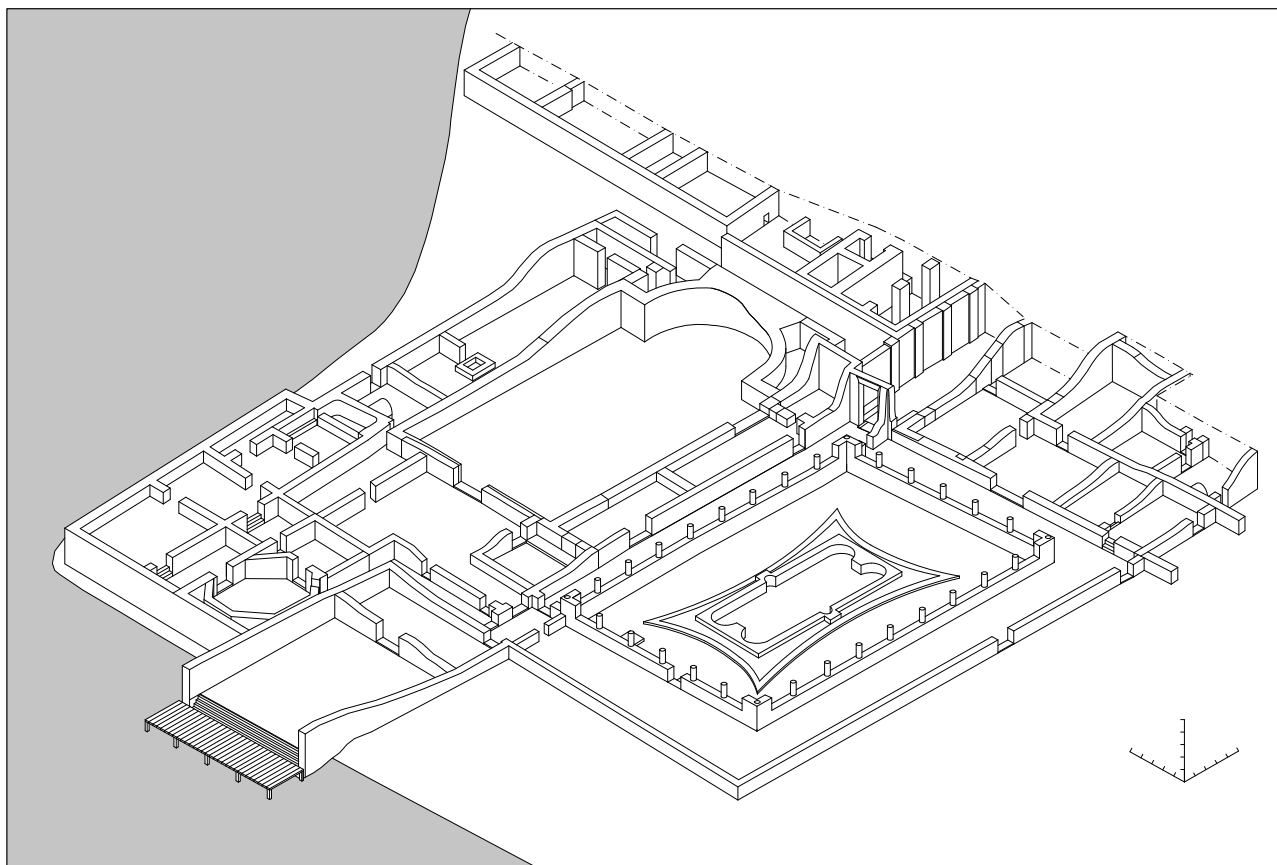
Figure 5.31. Axonometric reconstruction of the domus in Phase 5

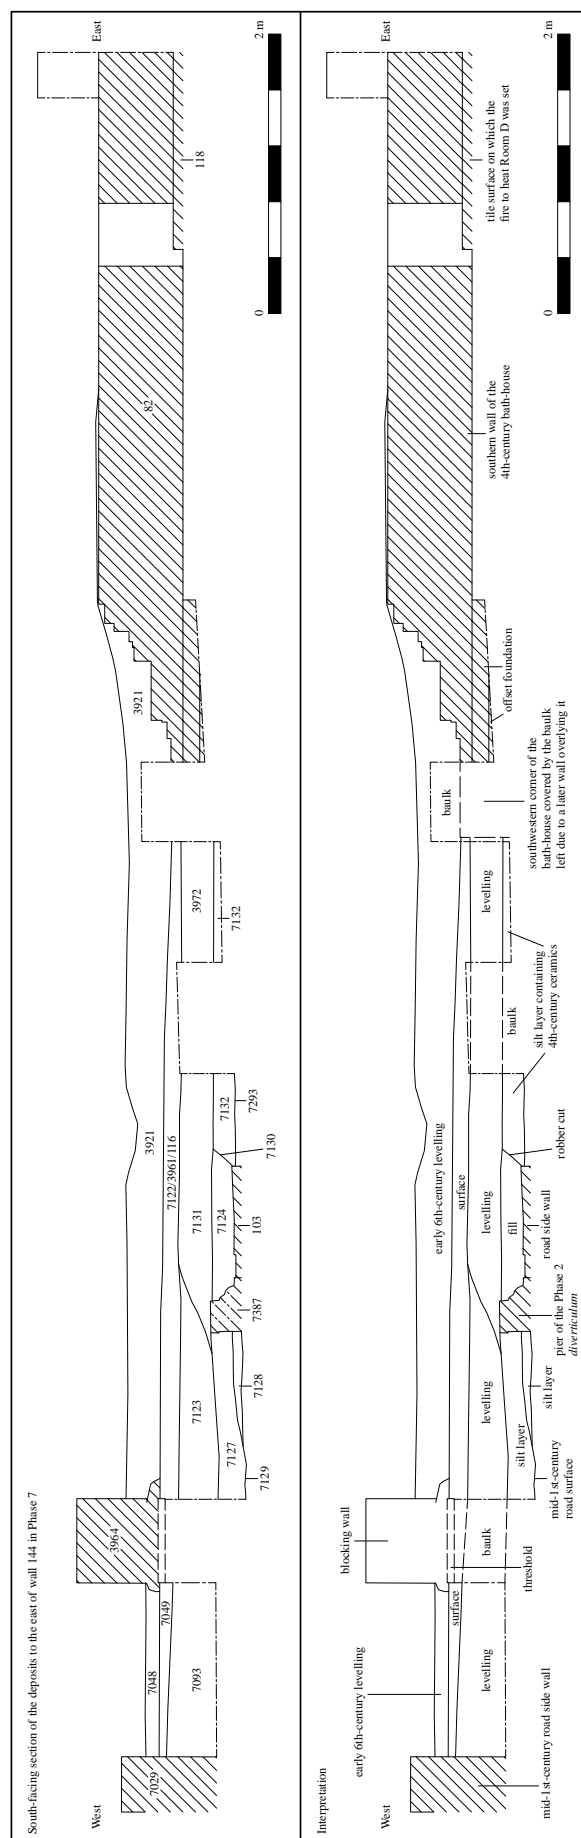
Figure 6.51. South-facing section of the Phase 7 features and deposits in the area between the western side of the Phase 3b eastern bath-house and apse of the apsidal hall

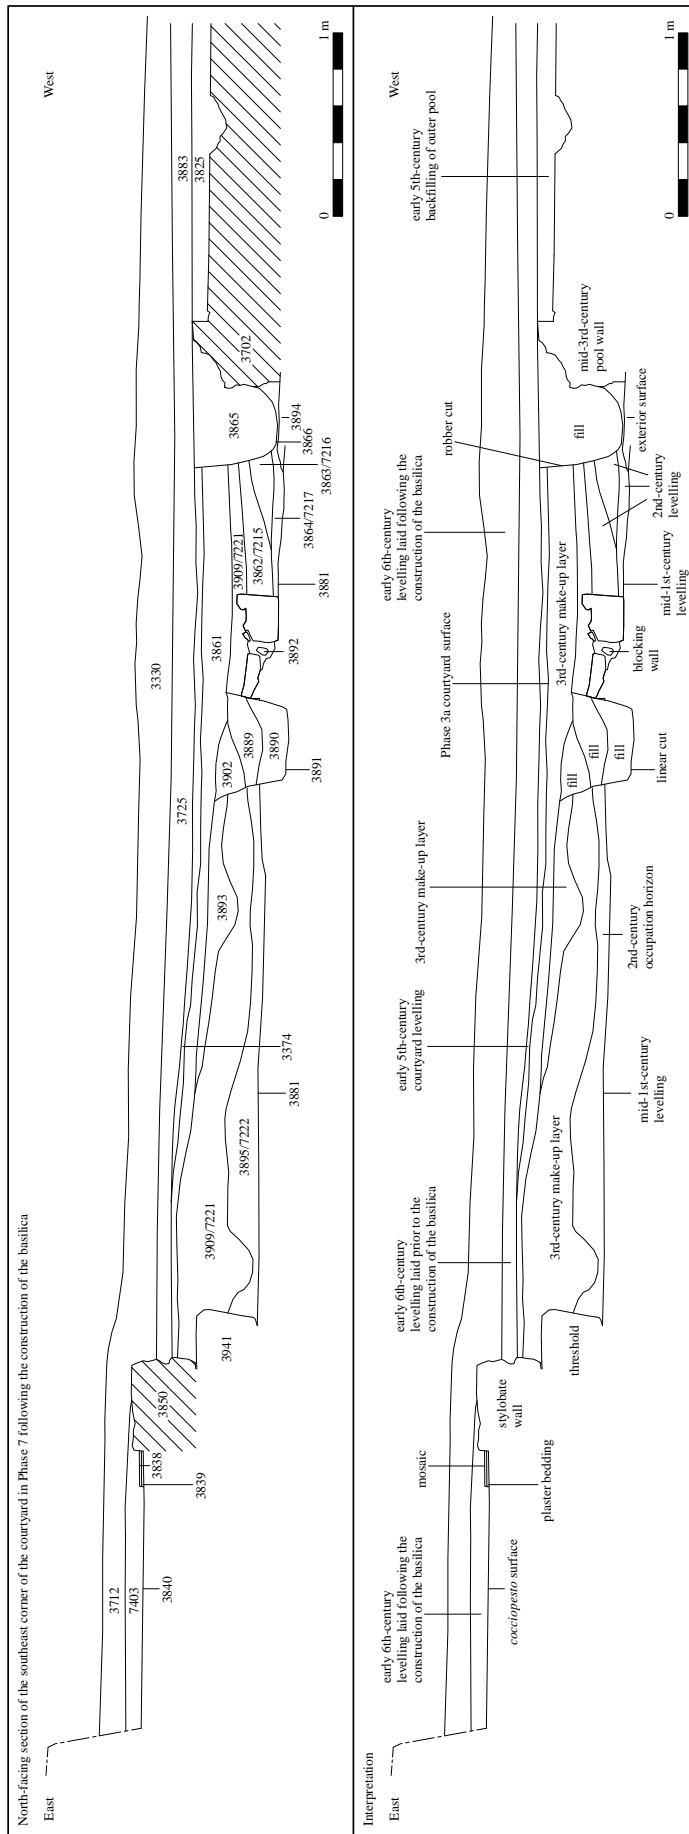
Figure 6.70. North-facing section across the southeast corner of the courtyard showing the Phase 7 alterations made following the construction of the basilica. See Fig. 6.69 for location
